**SUMMARY REQUEST FOR CERTIFICATE OF EXEMPTION TO THE ENVIRONMENTAL
PROCESS FOR THE DEWATERING OF J4 AND 87 PITS.**

Troilus Gold Corp.

Request For Certificate Of Exemption To The Environmental Process For The Dewatering of J4 And 87 Pits.

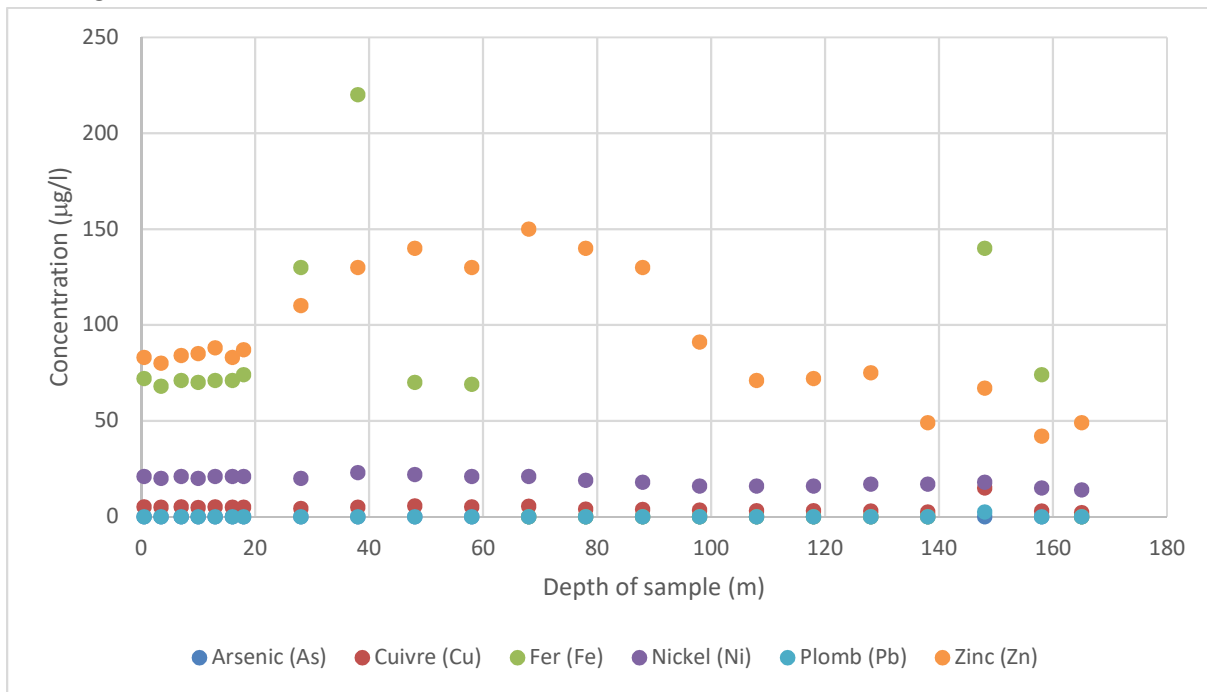
In the following figures, we see that for both pits, and at all depths, the water will be of good quality for discharge:

Figure 3.2 - Concentrations of different metals in relation to depth in pit J4

Table 3.6 presents the criteria for Directive 019 for the following parameters: arsenic, copper, iron, nickel, lead, zinc, cyanides, petroleum hydrocarbons and materials in suspension. The graphs in Figures 3.2 and 3.3 present the results for the parameters for which criteria are found in Directive 019, for pits 87 and J4. The other parameters that have been measured are presented in Appendix D of the French document.

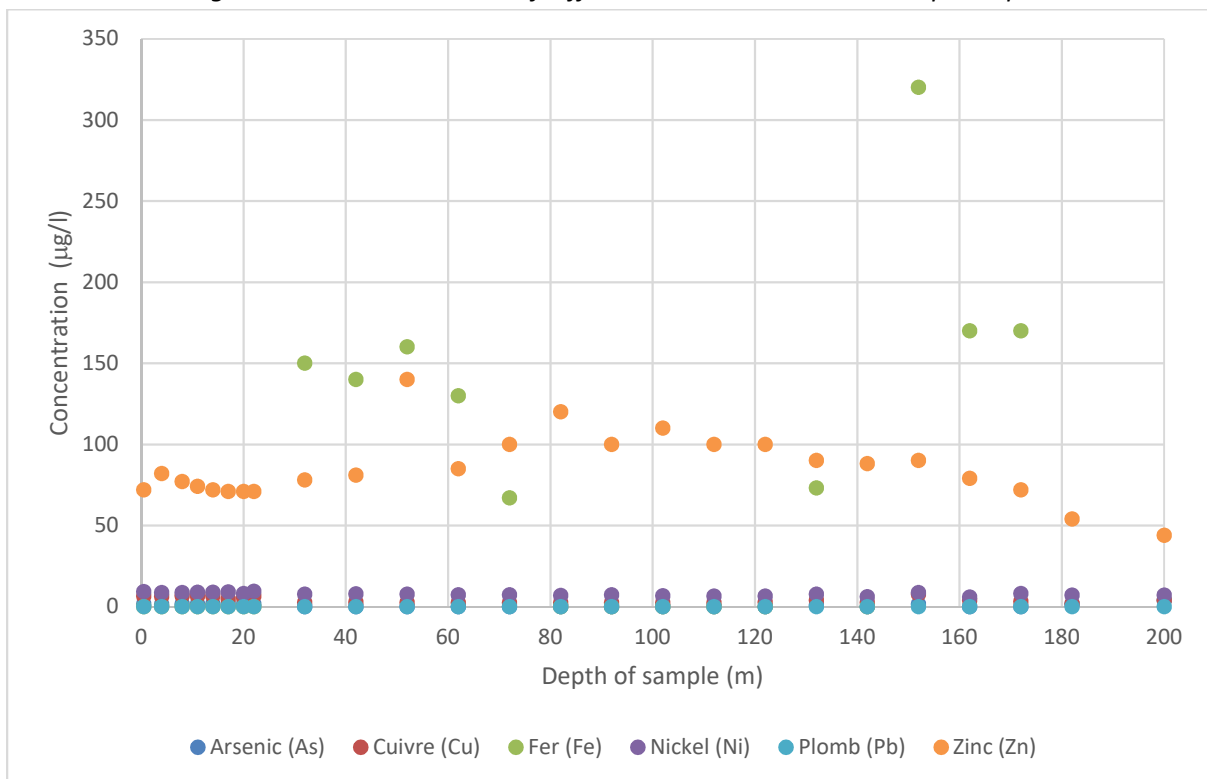
Figure 3.3 : Concentrations of different metals related to the depth of 87 pit.
