Lithium Guo AO :Projet Moblan Lithium H357755

Inventaire des milieux humides (Hatch, 2019)

Wetlands Survey of Lake Moblan Site

H357755-00000-200-066-0009

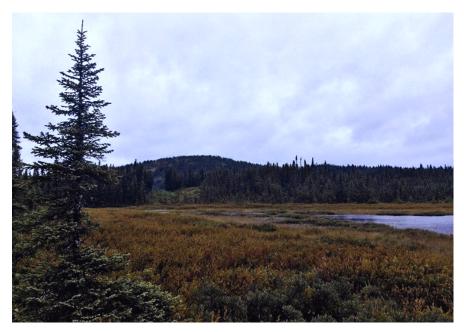
Wetland 1 is a 0.8 ha organic lacustrine shrub swamp surrounding the northern half of Unnamed Pond #1 (Figure 3-2). The pond is approximately 1.35 ha in size. Steep topography along the southern portion of the pond prevents the formation of wetlands along that portion of the shoreline. The shrub swamp ranged in width from several metres to approximately 40 m. The boundary of the swamp is abrupt on the pond side due to a substantial change in water depth, giving way to aquatic conditions. On the landward side, the boundary follows the edge of a shrub community composed primarily of leatherleaf (*Cassandra calyculata*) and sweet gale (*Myrica gale*). Elevation at the wetland boundary on the landward side increased by approximately 0.5 m from wetland to terrestrial communities although similar shrub species were found on either side of the delineated boundary and found at elevations several metres above the delineated boundary. A small (<<0.5 ha) emergent marsh community exists within the north-east section of the largest shrub swamp. The most common species in the herbaceous layer were sedges (*Carex sp.*), common brown peat moss (*Sphagnum fuscum*) and cloudberry (*Rubus chamaemorus*) Black spruce was dominant along the periphery of much of the wetland.

Figure 3-2- Photograph of Wetland 1, an organic lacustrine shrub swamp surrounding the northern half of Unnamed Pond #1

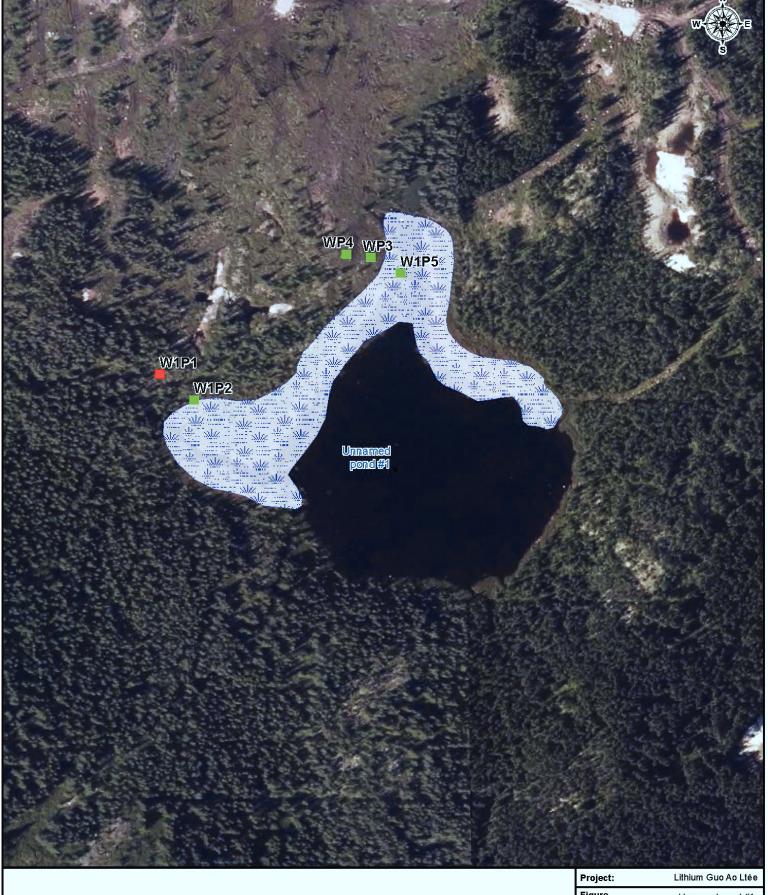
Figure 3-3- Boundary of Wetland #1

Most of the delineated boundary of Wetland 1 follows the edge of the wetland shrub community which is approximately 50 cm lower than the adjacent upland vegetation (Fig. 3.3). The more gradual topography at the west end extended the wetland into the adjacent black spruce community and to the east the boundary follows the edge of an emergent marsh.

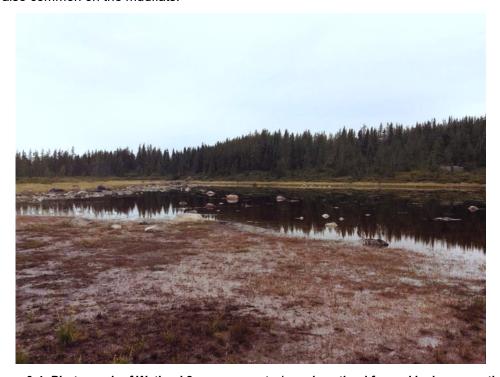
Wetland 2 is a shallow open water/marsh complex that has developed as a consequence of the natural succession of an abandoned beaver pond (Figure 3-4). The entire system in its present condition is considered wetland under the Canadian Wetland Classification system.

Figure 3-4- Photograph of Wetland 2, an open water/marsh wetland formed by beaver activity

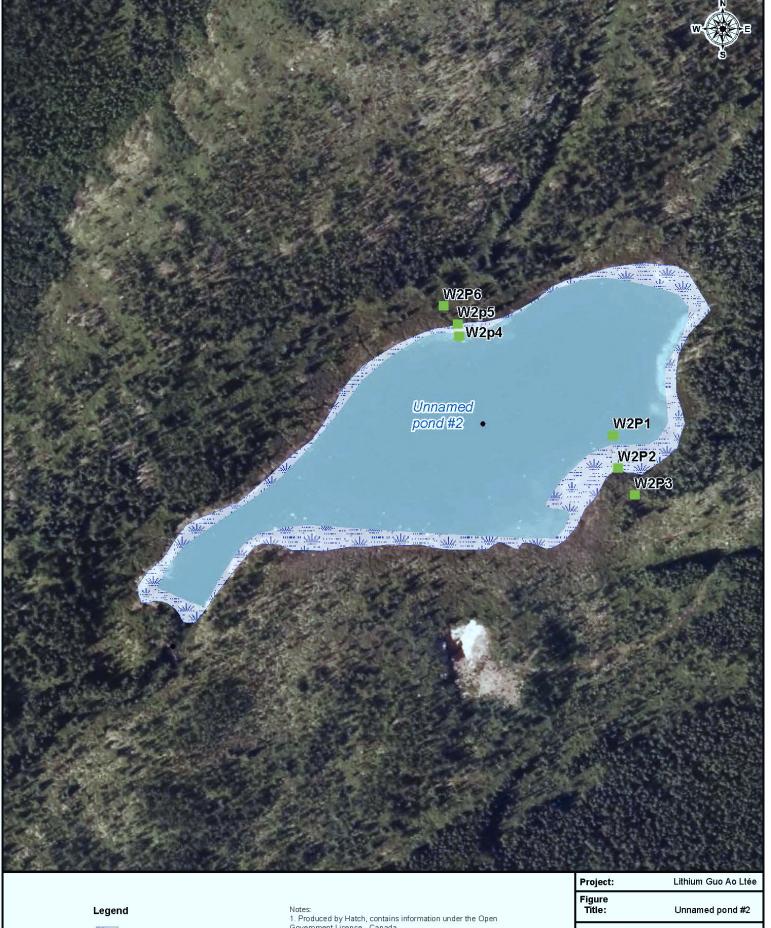
Figure 3-5-Boundary of Wetland #2

The delineated wetland boundary (Figure 3-5) follows the border between the mudflats and a narrow ring of a leatherleaf dominated shrub community where there is an approximately 50 cm rise in elevation. This shrub community quickly transitions into a jack pine black spruce forest around most of the periphery.

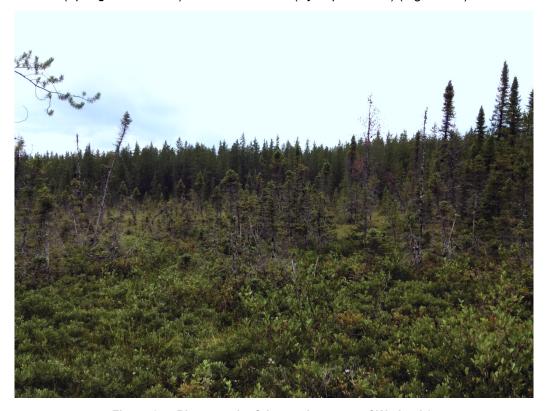
The northern shrub fen is sparsely treed with black spruce (*Picea mariana*) and jack pine (*Pinus banksiana*). The predominant shrub layer contains sweet gale (*Myrica gale*), leatherleaf (*Chamaedaphne calyculata*) and sheep laurel (*Kalmia angustifolia*). The herbaceous/ground layer includes clubmoss, woolgrass (*Scripus cyperinus*), common ground peat moss (*Sphagnum fuscum*) and feather moss (*Hyne plumeuse*) (Figure 3-7).

Figure 3-7- Photograph of the northern arm of Wetland 3.

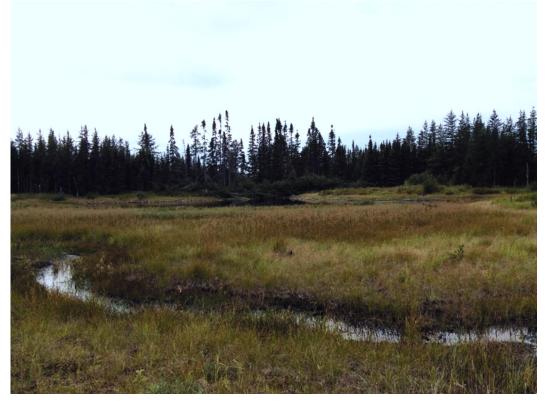
Both arms of the fen transition into the beaver pond wetland. Seasonally low water level has resulted in exposed mudflats over much of the eastern half of the pond which have been colonized by such species as black-girdled woolgrass (*Scirpus atrocinctus*), star sedge (*Cared radiata*), jointed rush (*Juncus articulates*) and northern long sedge (*Carex folliculate*, Figure 3-8).

Figure 3-8- Photograph from taken from the eastern end of the Wetland 3 marsh, showing the narrow-leaved emergent marsh community. The abandoned beaver dam is in the background.
