Under Test: TC4013-8  
S/N: 1319189  
Reference: TC4033  
Date: 2019-08-21  
Session, Run: 32686, 3  
Max RR: -217.8 dB re 1 $\mu$ Pa/V at 1m  
SL Right: 25.0°, 0.0dB dB re 1 $\mu$ Pa/V at 1m  
Comment: Horizontal.

## HYDROPHONE DIRECTIVITY

PR10.2 (10 de 12) Description  
des travaux 2020

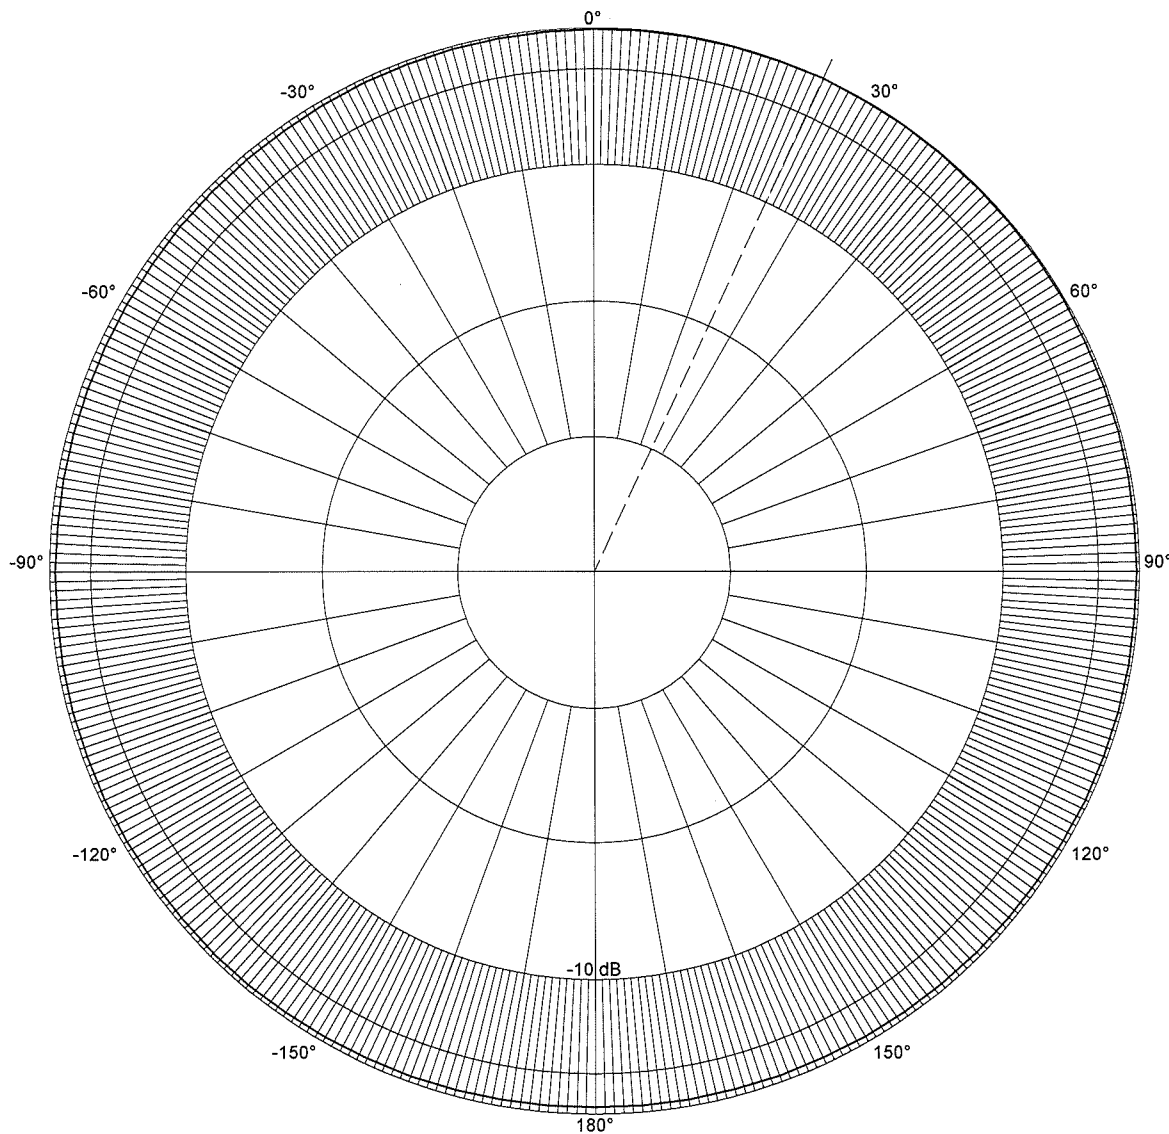
Amplitude: 20.0 Vrms  
Pulse Width: 166.7  $\mu$ s  
Angle: -180.0° to 180.0°  
Frequency: 90.00 kHz

Temperature: 23.17°C  
Depth: 1.2 m  
Distance: 0.50 m  
Tested by: PRA

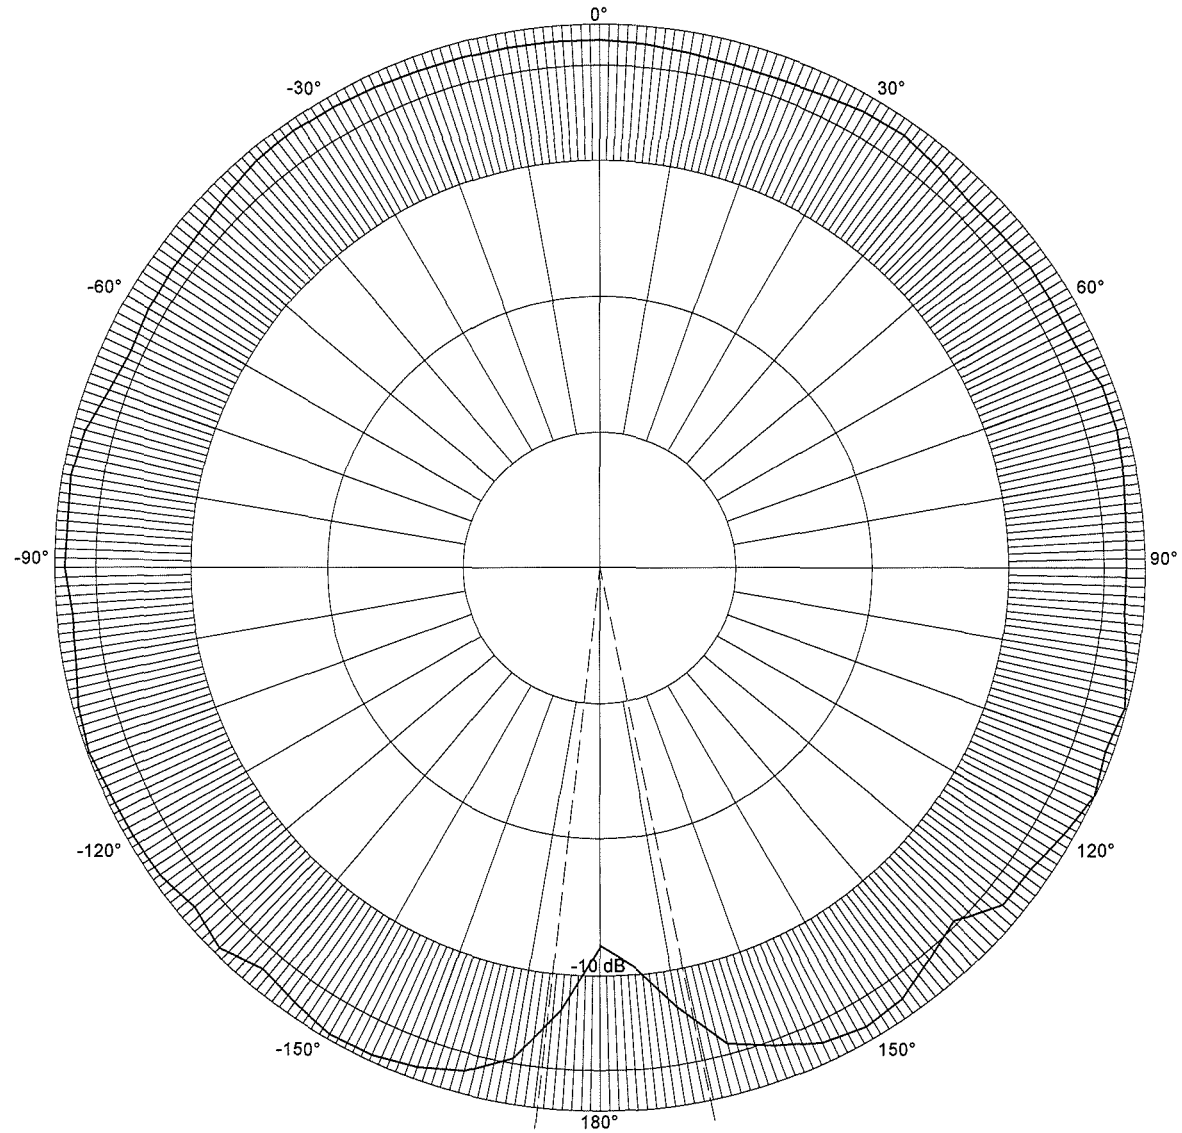
# HYDROPHONE DIRECTIVITY

Under Test: TC4013-8  
S/N: 1319189  
Reference: TC4033  
Date: 2019-08-21  
Session, Run: 32686, 2  
Max RR: -216.4 dB re 1 $\mu$ Pa/V at 1m  
W: 341.6°  
Comment: Vertical.

Amplitude: 10.0 Vrms  
Pulse Width: 166.7  $\mu$ s  
Angle: -180.0° to 180.0°  
Frequency: 90.00 kHz

Temperature: 23.17°C  
Depth: 1.2 m  
Distance: 0.50 m  
Tested by: PRA

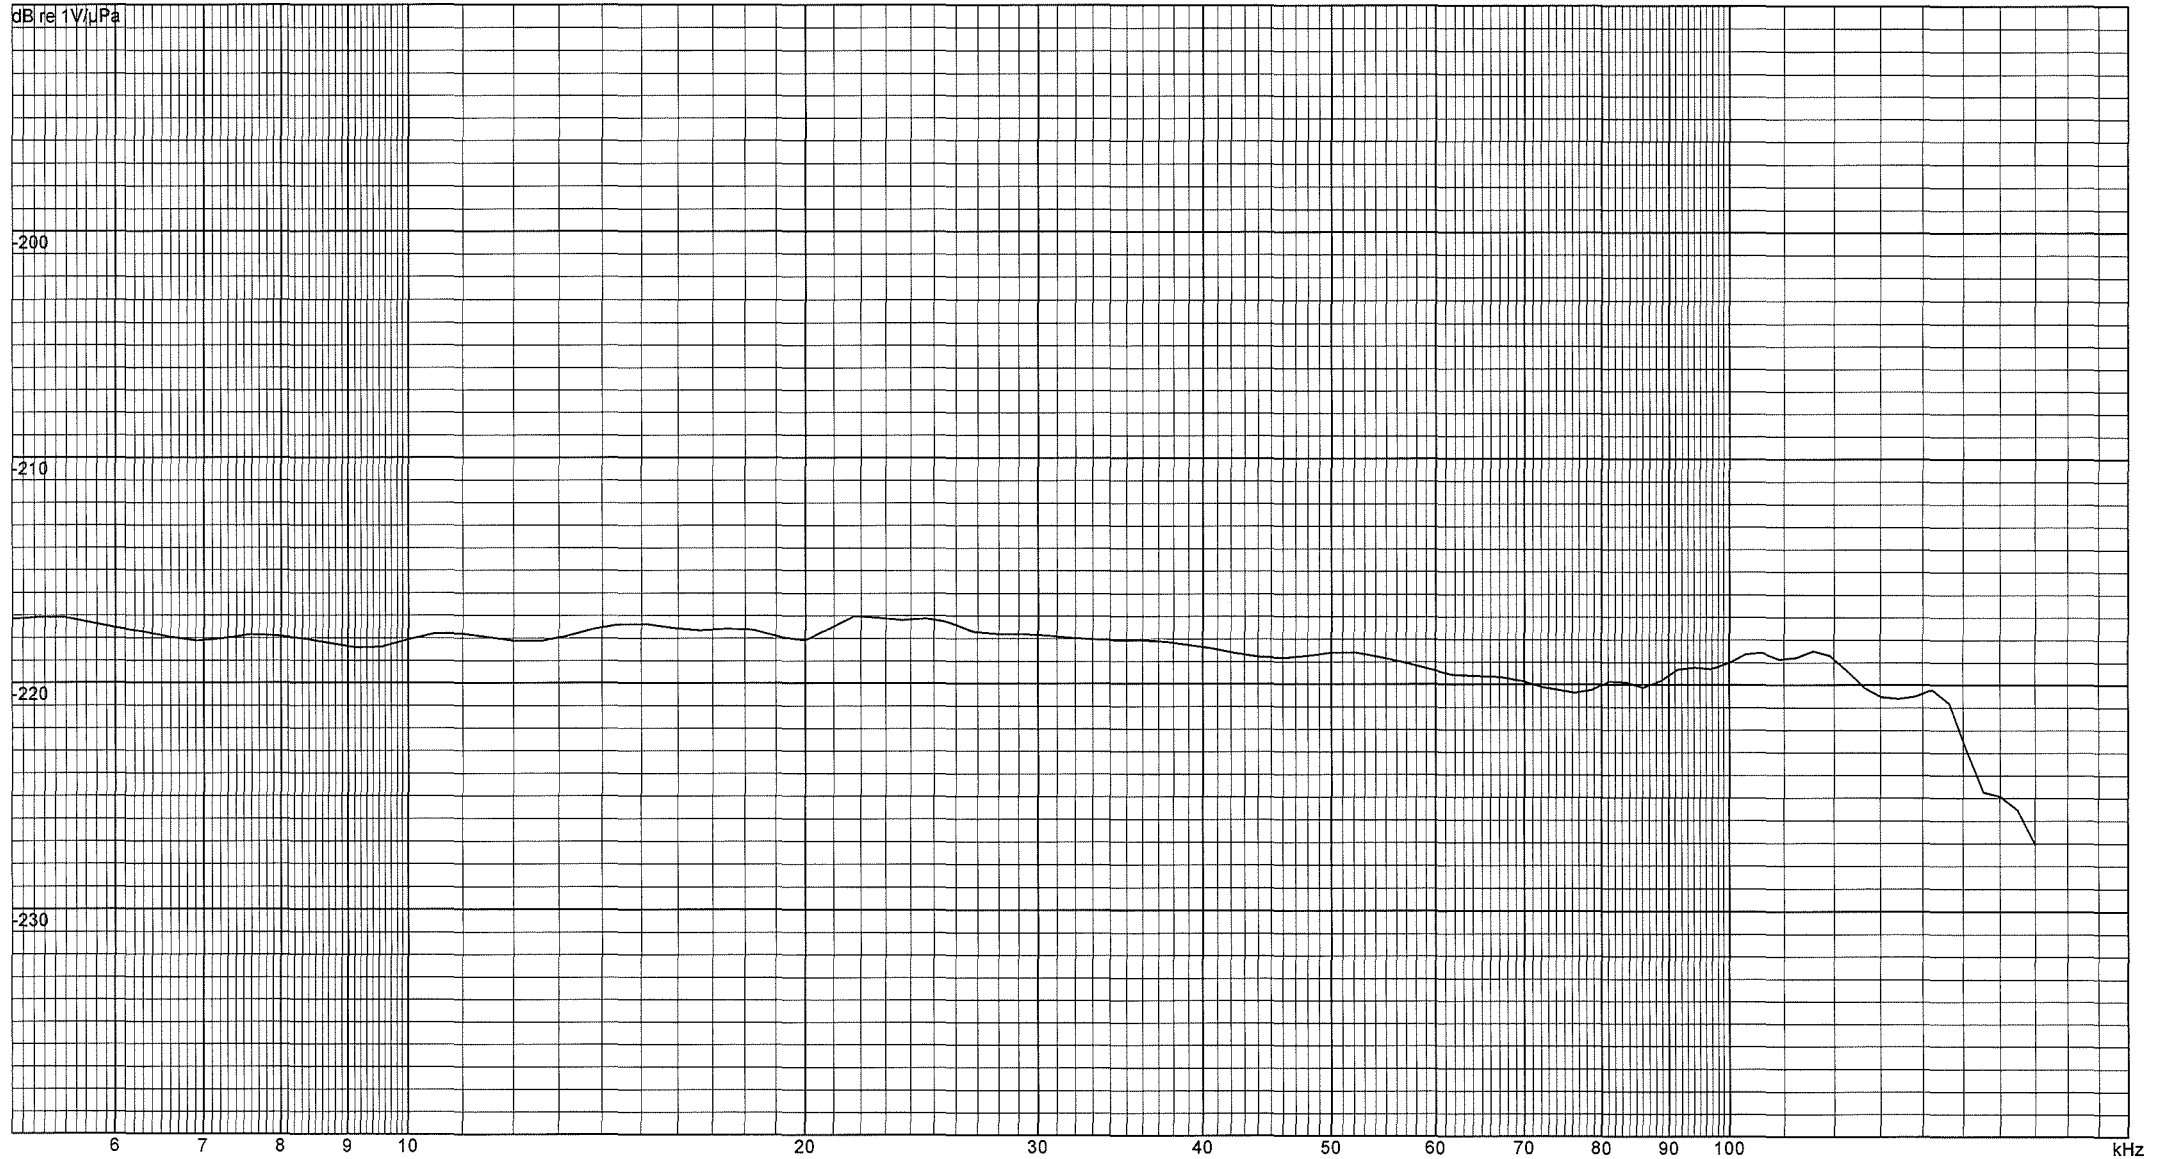
# HYDROPHONE SENSITIVITY

Under Test: TC4013-8  
S/N: 1319189  
Reference:  
Date: 2019-08-21  
Session, Run: 32686, 4  
Comment:

Amplitude: 70.0 Vrms  
Pulse Width: 1400.0  $\mu$ s  
Rep Rate: 66.7 ms  
Averages: 8

PHO @ 250 Hz: -217.2 dB.

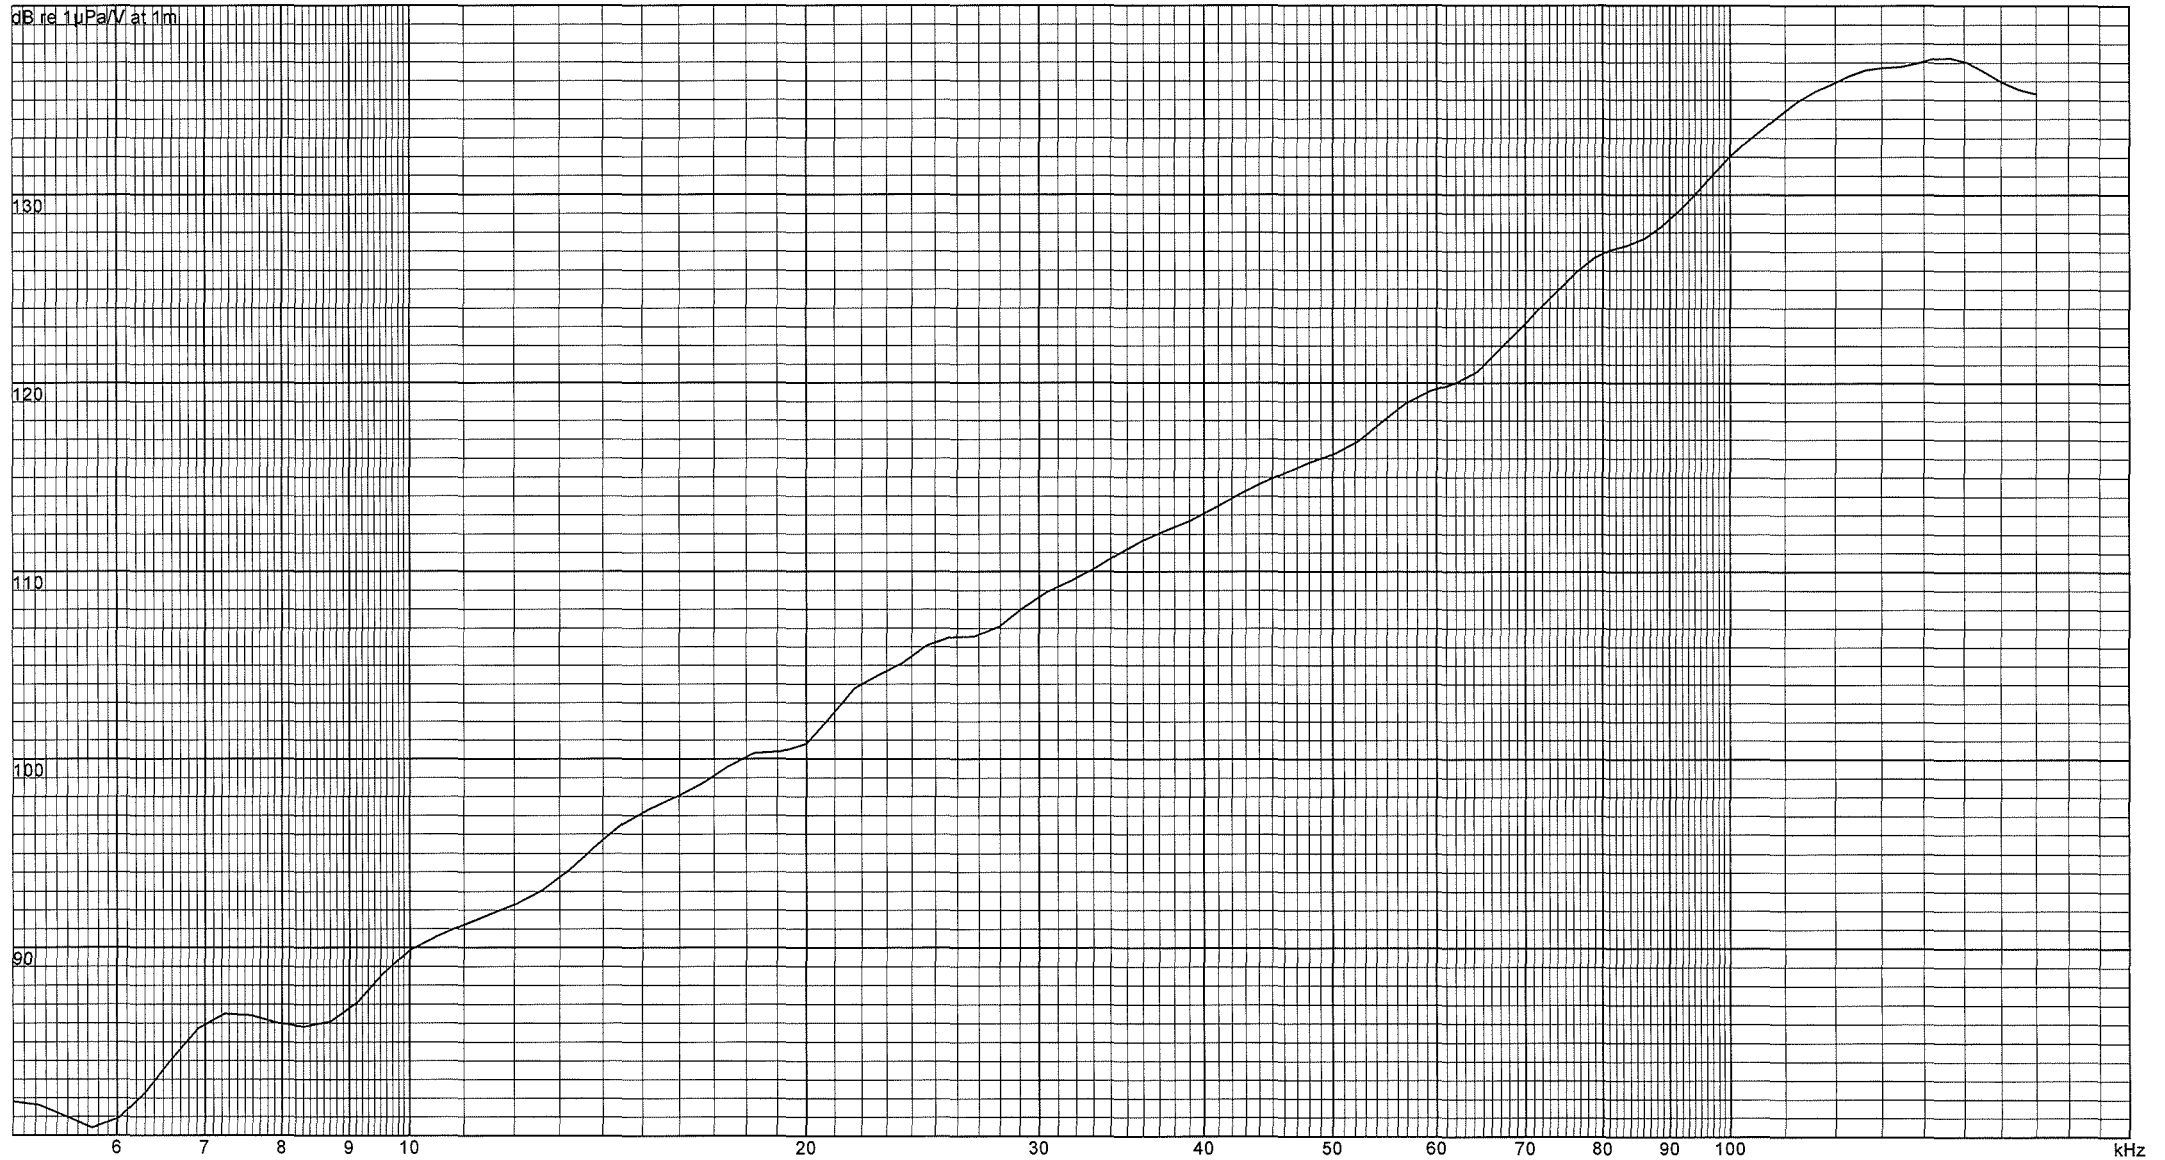
Under Test: TC4013-8  
S/N: 1319189  
Reference:  
Date: 2019-08-21  
Session, Run: 32686, 7  
100.00 kHz: 132.03 dB re 1 $\mu$ Pa/V at 1m  
Comment:

## PROJECTOR SENSITIVITY

Amplitude: 9.5 Vrms  
Pulse Width: 1400.0  $\mu$ s  
Rep Rate: 100.0 ms  
Averages: 8

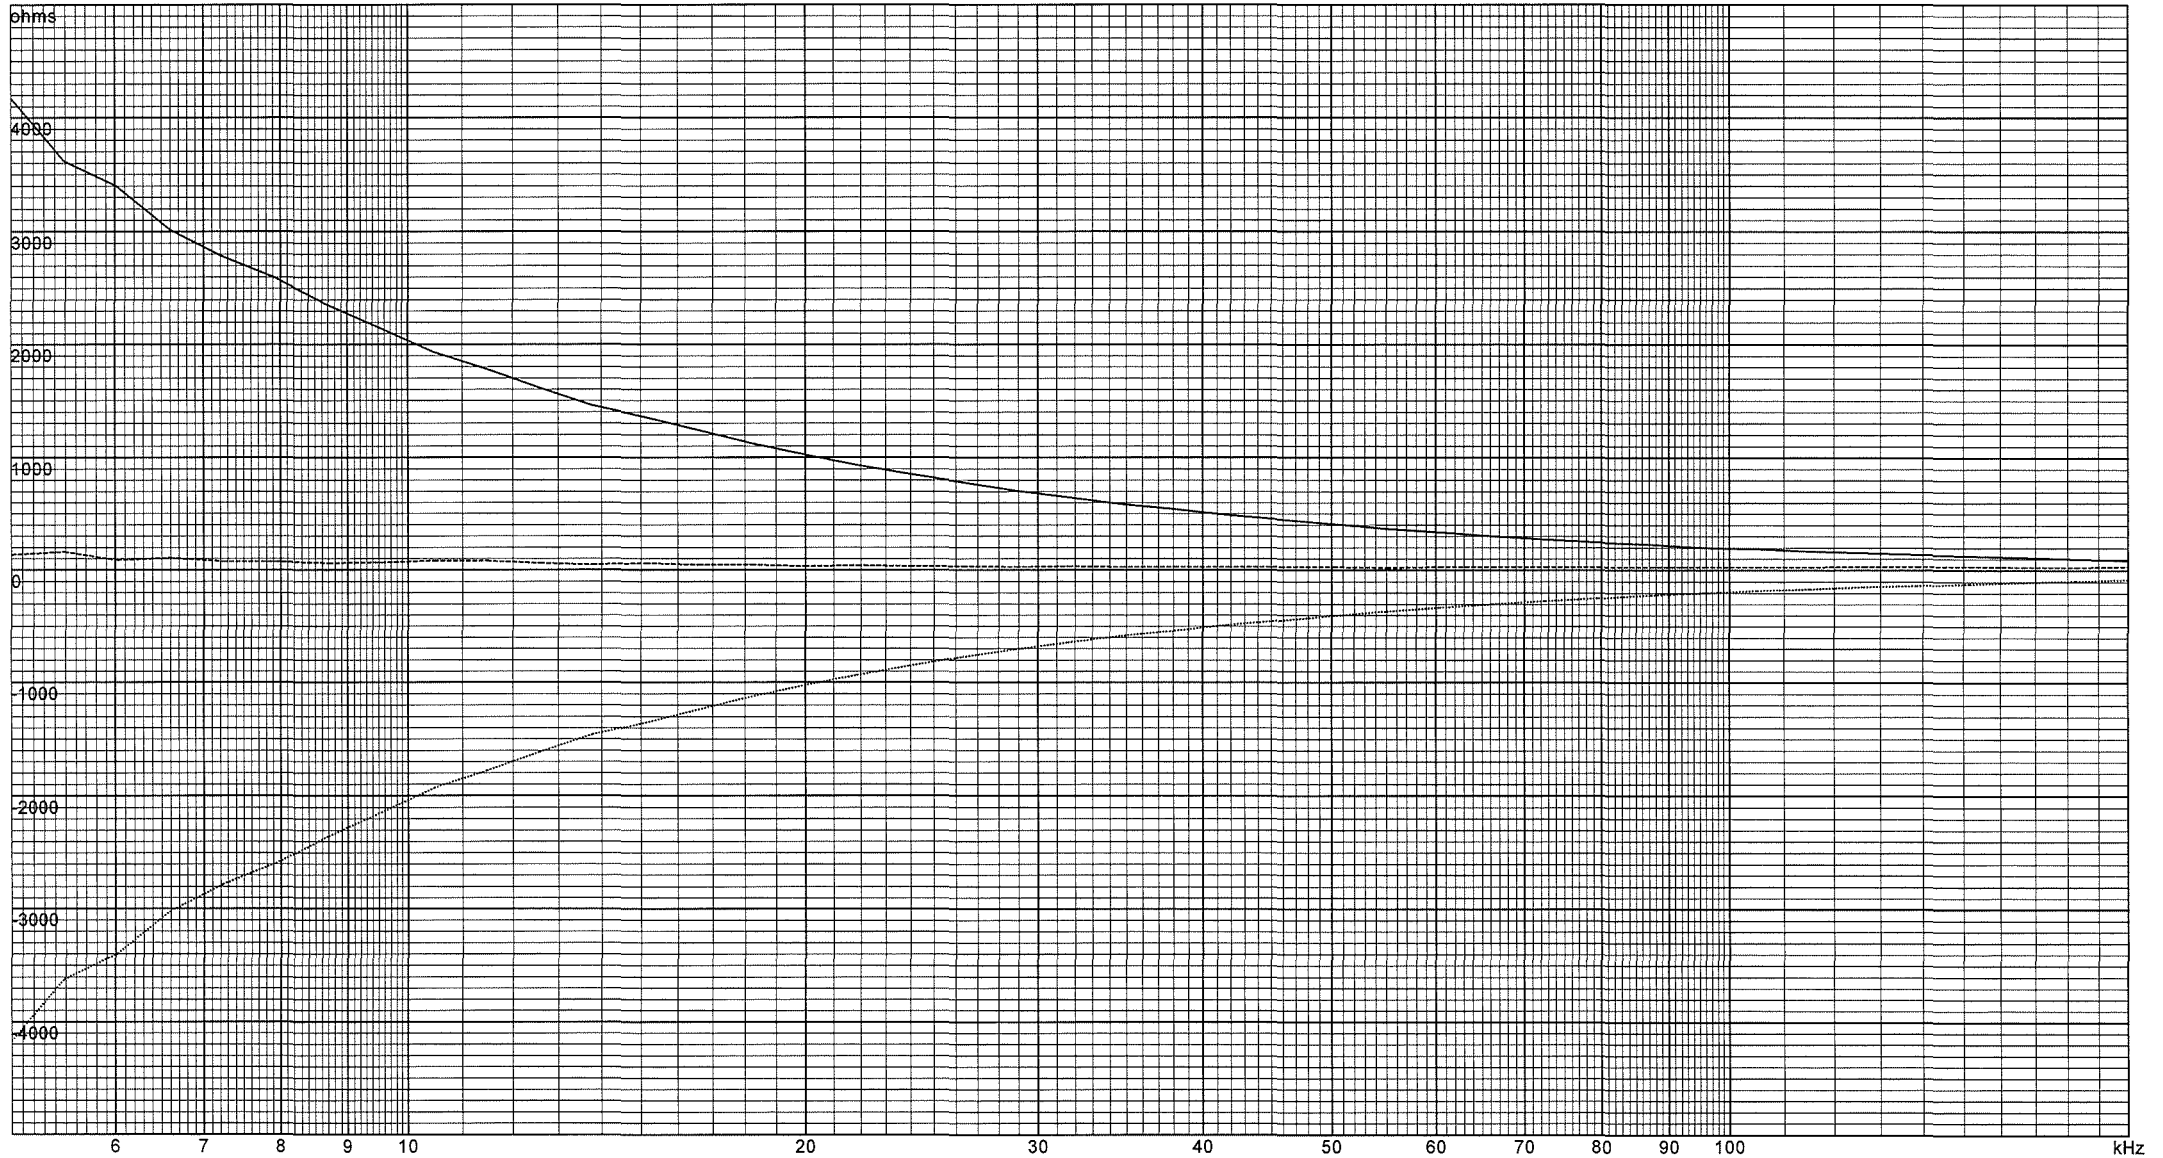
Date: 2019-08-21  
Session, Run: 32686, 8  
Comment:

## IMPEDANCE SUMMARY

Amplitude: 10.0 Vrms  
Pulse Width: 3000.0  $\mu$ s  
Rep Rate: 33.3 ms  
Averages: 4

Temperature: 23.17°C  
Depth: 1.2 m  
Cal Resistor: 0.0 ohms  
Tested by: PRA

— 1319189\Impedance\1\Impedance\Try 1  
- - - 1319189\Impedance\1\Resistance\Try 1  
..... 1319189\Impedance\1\Reactance\Try 1
