**ENVIRONMENTAL EVALUATION – DEWATERING OF J4 AND 87 PITS
SUMMARY**

November 2019

Troilus Gold Corp.

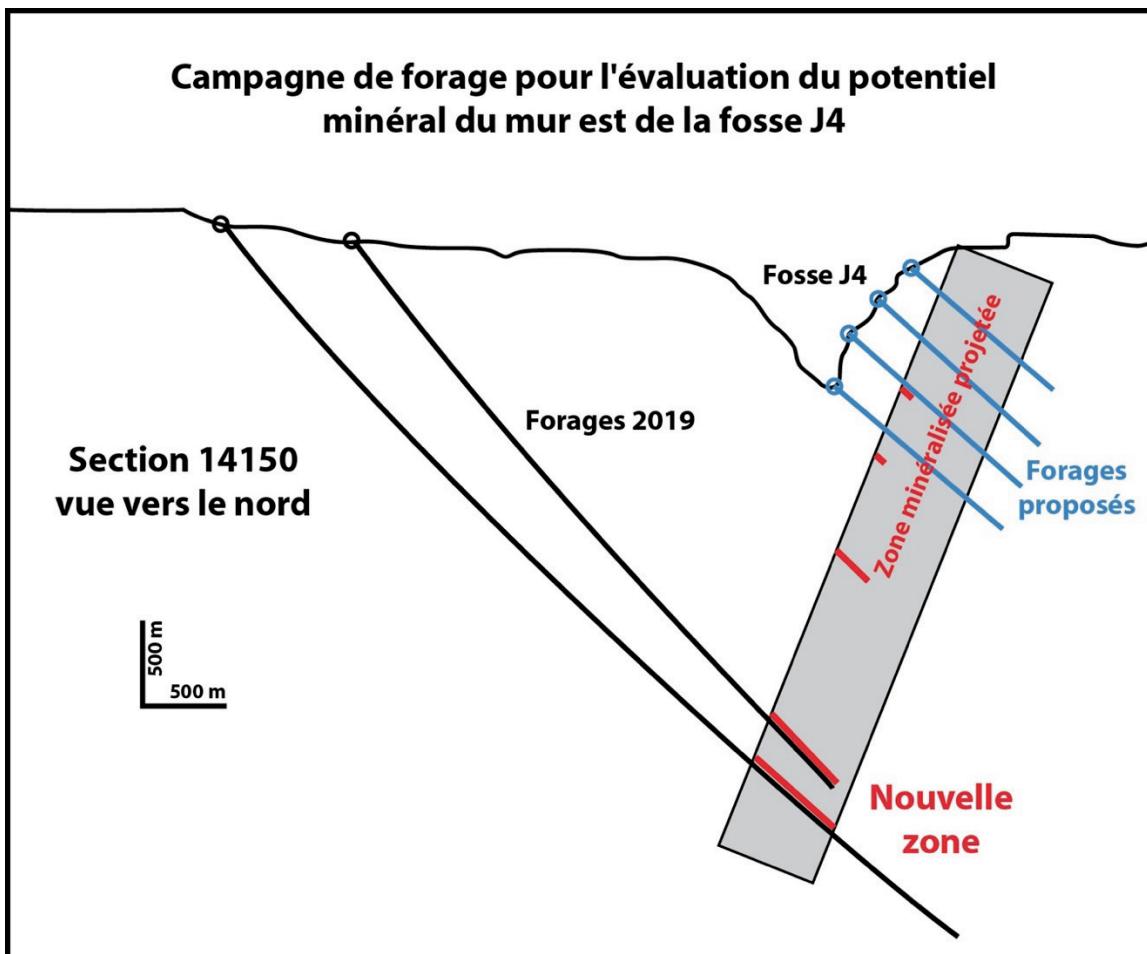
Figure 3.1 Diagram of proposed drill holes

The dewatering of the J4 and 87 pits will allow the installation of diamond drills on the benches to drill to the east (N123 °) at an angle of 45 °. The proposed program is 4 drill holes as shown in Figure 3.1. Drilling may also be done from the floor of the pits.

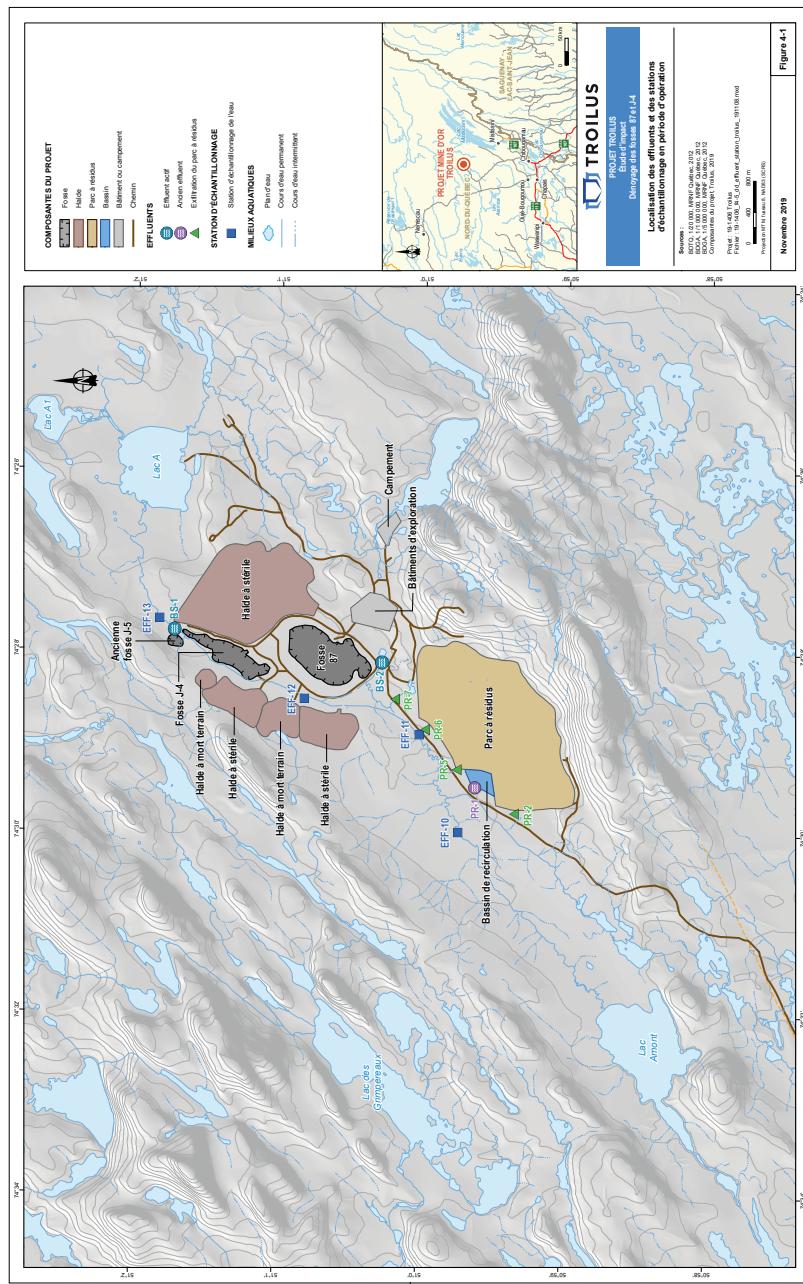
Figure 4.1 Location of sampling points when the mine was in opération

During the operation, stations were sampled regularly as part of the EEM follow-up of the Metal Mining Effluent Regulations (MMER) and provincial monitoring. Figure 4.1 shows the location of sampling stations and release points when the mine was in operation.

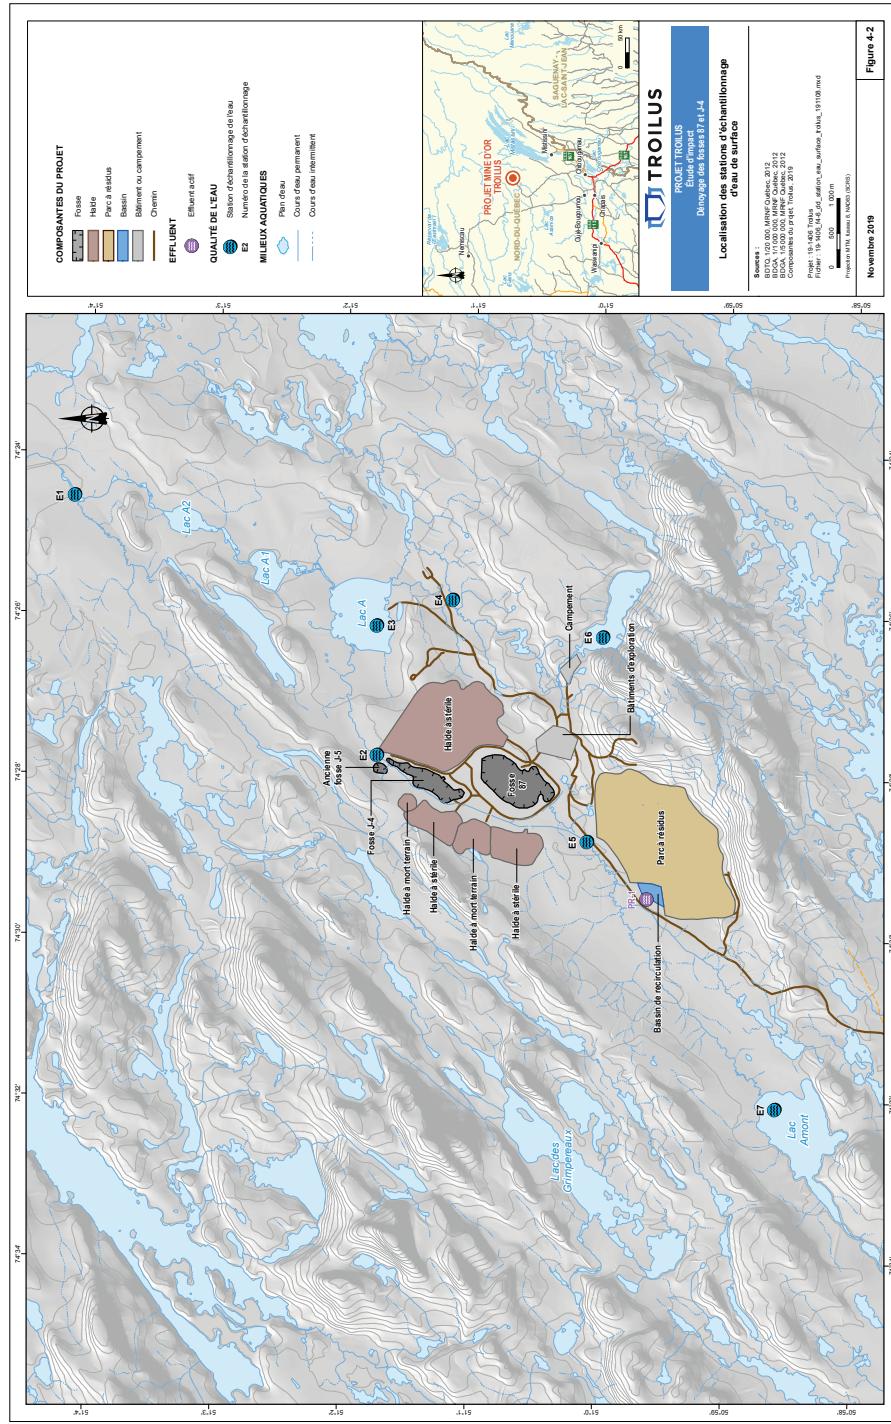
Figure 4.2 Location of sampling stations for surface water, summer and fall 2019

Recently, Troilus undertook a site characterization study to define the baseline in the event that the mine site will go back to operation. Sampling was carried out at various places on the property, in particular at the points shown in Figure 4.2. Thus, points E1 to E7 are sampled monthly and the parameters analyzed and the results are presented in Appendix G. In the case of dewatering of pits, it is sampling point E2 which is located closest to point of release that will be used to evaluate the effects of adding contaminants to the receiving environment.

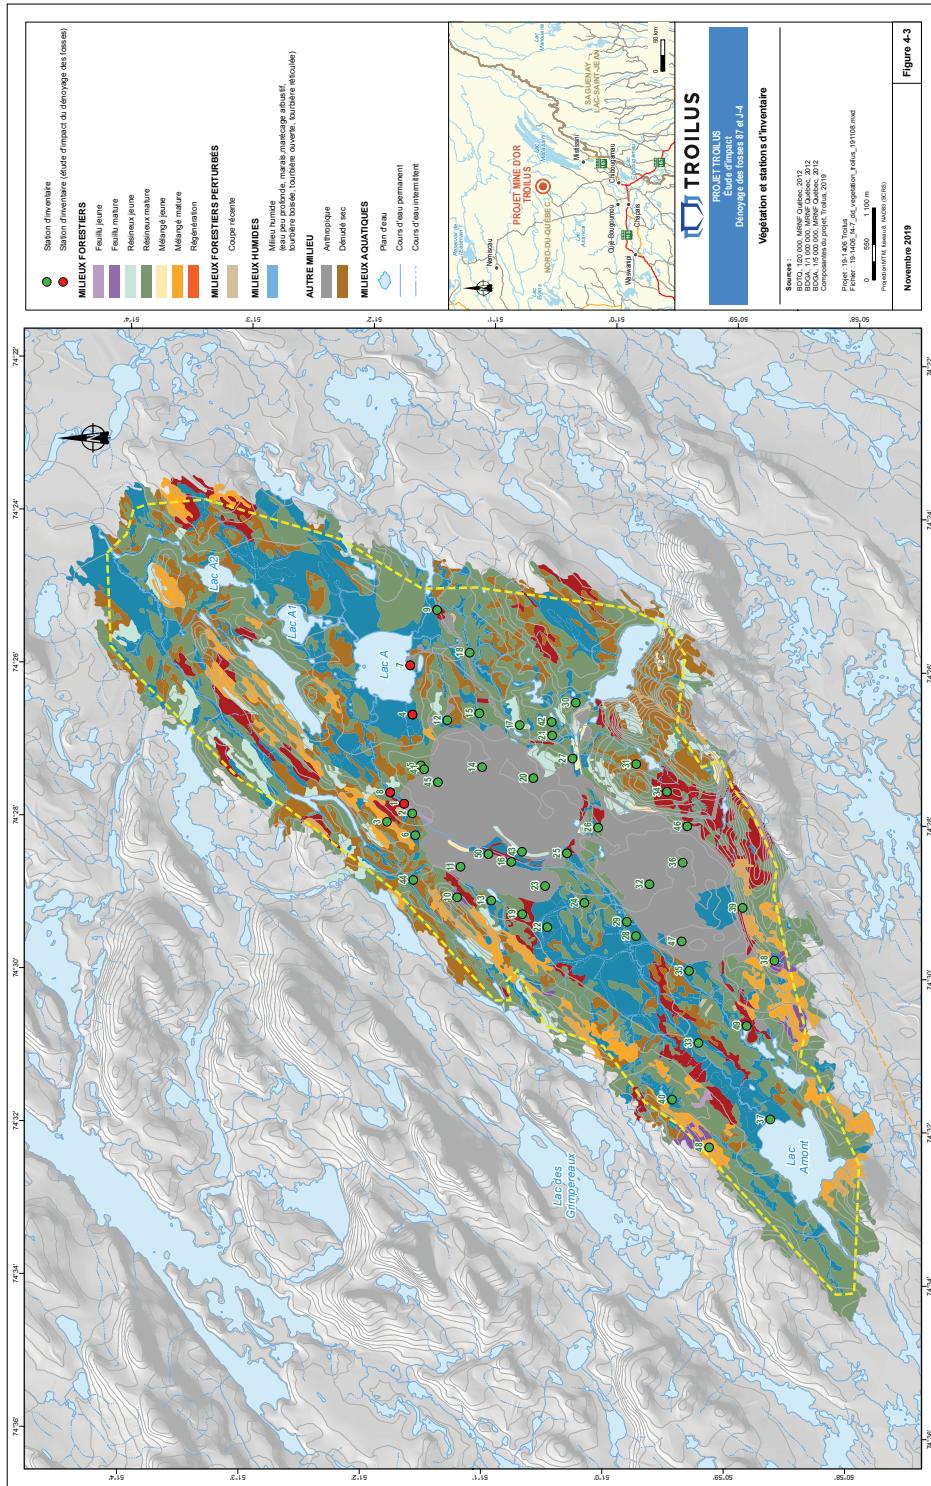
Figure 4.3 Vegetation map near the unnamed stream

The description of the vegetation and wetlands is largely based on the results of the 3D photo-interpretation and the floristic inventory conducted by Wachih in the study area. The vegetation inventory, conducted during the week of July 7, 2019, was concentrated mainly along the tributary of Lake A and near this lake.

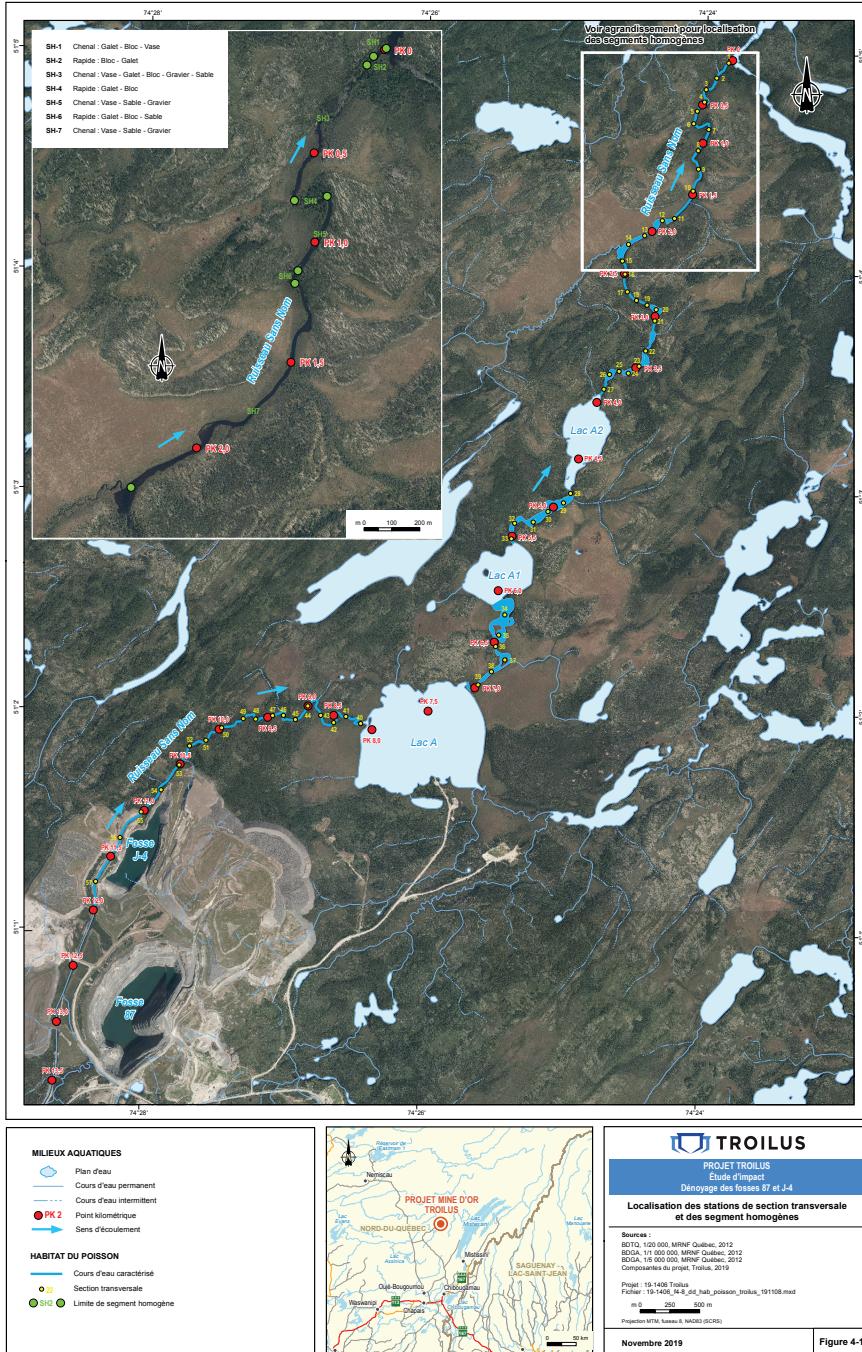
Figure 4.10 Location of homogenous segments (DDM, Appendix D of impact study)

In each of the watercourses characterized, there are potential or confirmed spawning grounds. Spawning grounds are identified from the quality of the substrates. Of the 14 spawning sites identified by a substrate (Wachiih), 3 were confirmed by the tallyman, Mr. Kenny Awashish. These sensitive habitats have been taken into account in the dewatering water discharge scenarios.

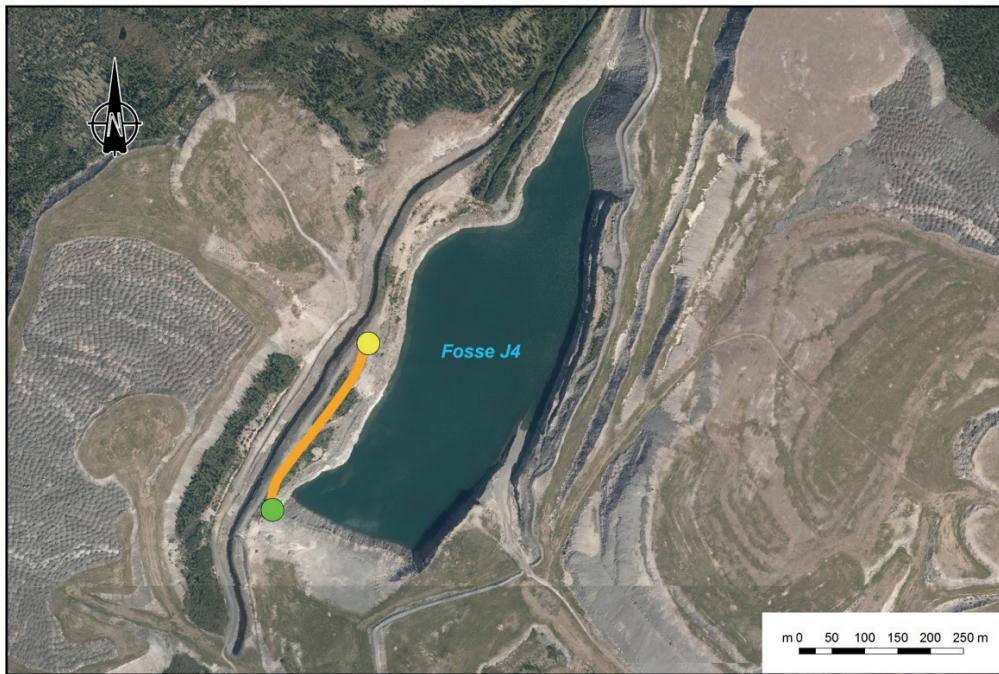
Figure 5.1 Water treatment plant location (green dot) and discharge point (yellow dot)

The treatment unit will be located west of pit J4, on a rock platform (green dot in Figure 5.1). One pipe will bring water to the discharge point (orange line) and the discharge point is shown in yellow in Figure 5.1.

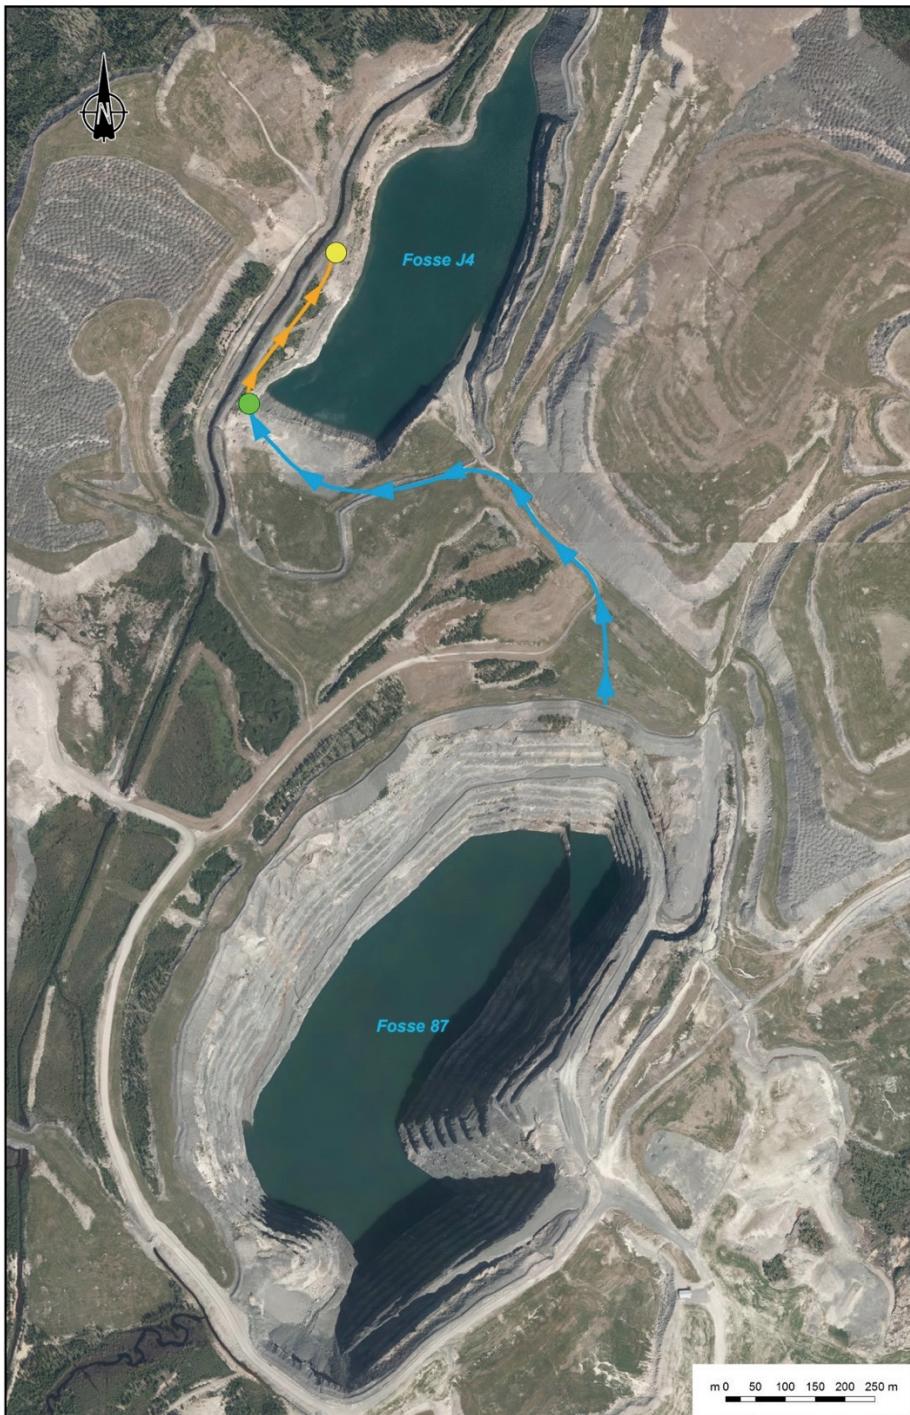
Figure 5.2 Water treatment plant location (green dot) and discharge point (yellow dot) and the discharge pipe from pit 87

For the dewatering of pit 87, the barge and the pipe will be brought to the pit 87. The water treatment unit and the point of discharge will remain in the same place and the water will be pumped with a pipe shown in blue on Figure 5.2.
